Assessment of Dam Safety of Coal Combustion Surface Impoundments

Coletto LP, LLC

Coletto Creek Power, LP

Draft Report

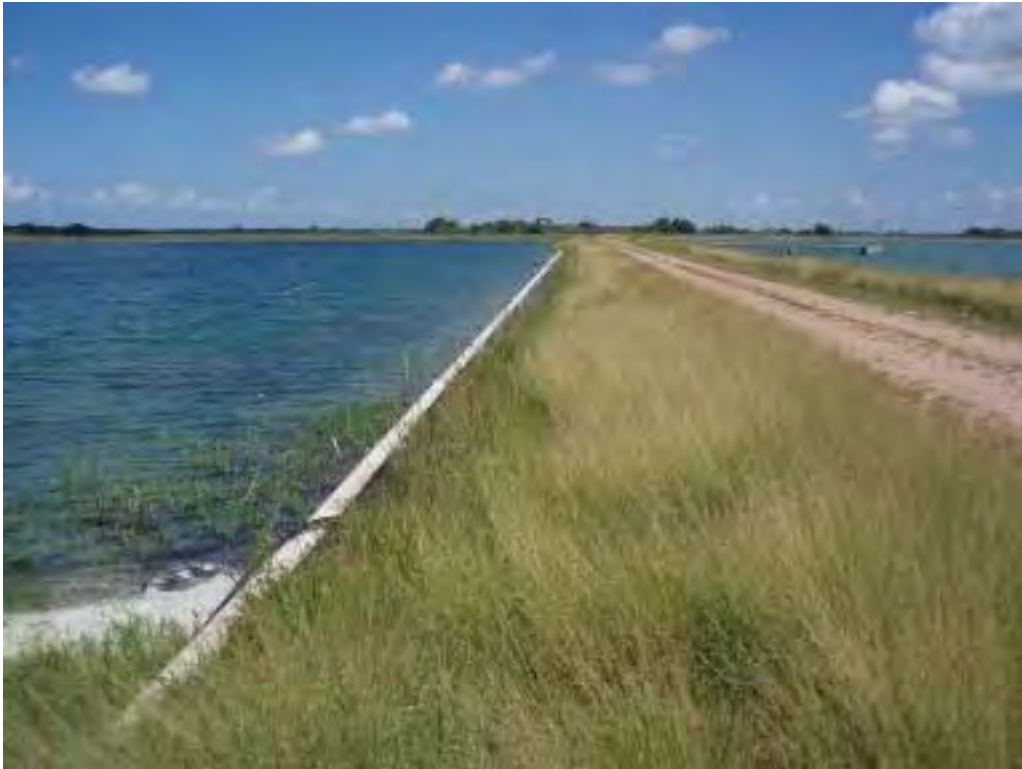
The visible portions of the interior slope generally appeared to be in fair to poor condition (Photos 1, 15, 42, 43, 46, and 47). The interior slopes on the north and east embankments and the northeast slope of the divider embankment were approximately 3H: 1V.

The 8-inch-diameter discharge pipe from the recirculating pump station was observed on the northeast slope of the divider embankment (Photos 1, 4, and 15). The discharge pipe was supported on concrete piers spaced at approximately 10 feet on center.

Photo No. 1: Secondary Pond - Northeast slope of divider embankment from northwest corner, looking southeast.

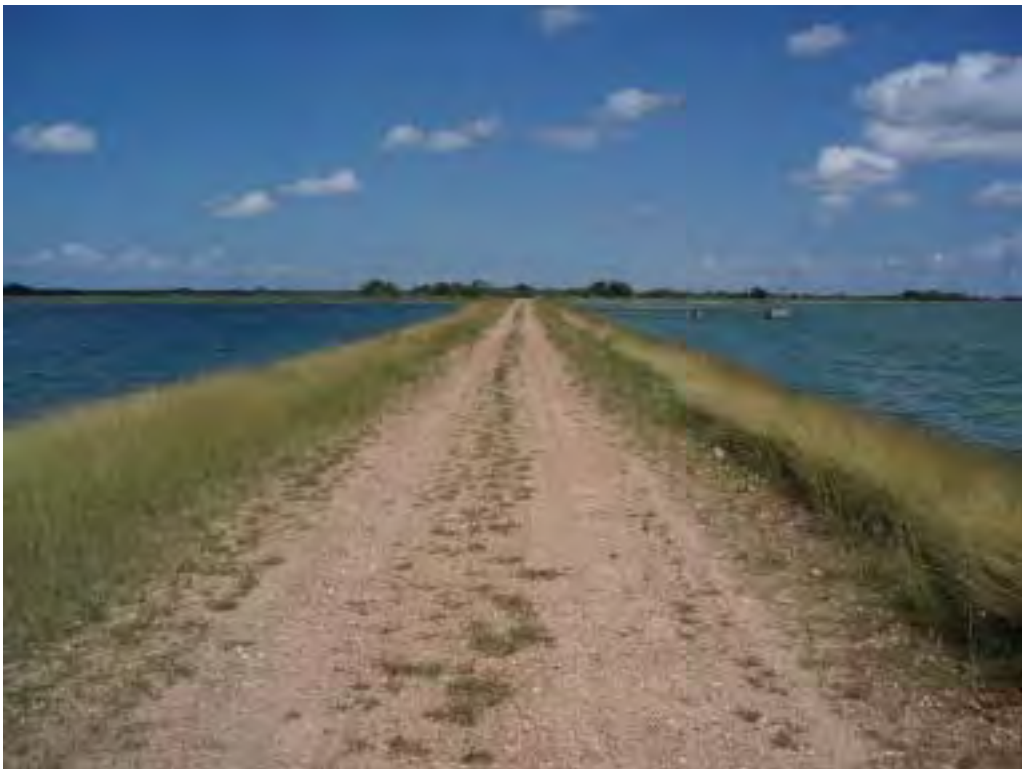
The crest of the Secondary Pond embankments appeared to be generally in fair condition (Photos 2, 14, 17, 41, 46, and 47). The crest was generally approximately 20 feet wide. The crest is surfaced with compacted gravel and is used as an access road. Sparse vegetation was growing in the middle and on both sides of the roadway. A barbed wire fence used to contain livestock was observed on the north and east embankment crest perimeter (Photos 46, 47, and 48). The vertical alignment of the fence posts was in good condition. Observed freeboard at the time of the visit was approximately three feet.

Photo No. 2: Crest of divider embankment from northwest corner, looking southeast.

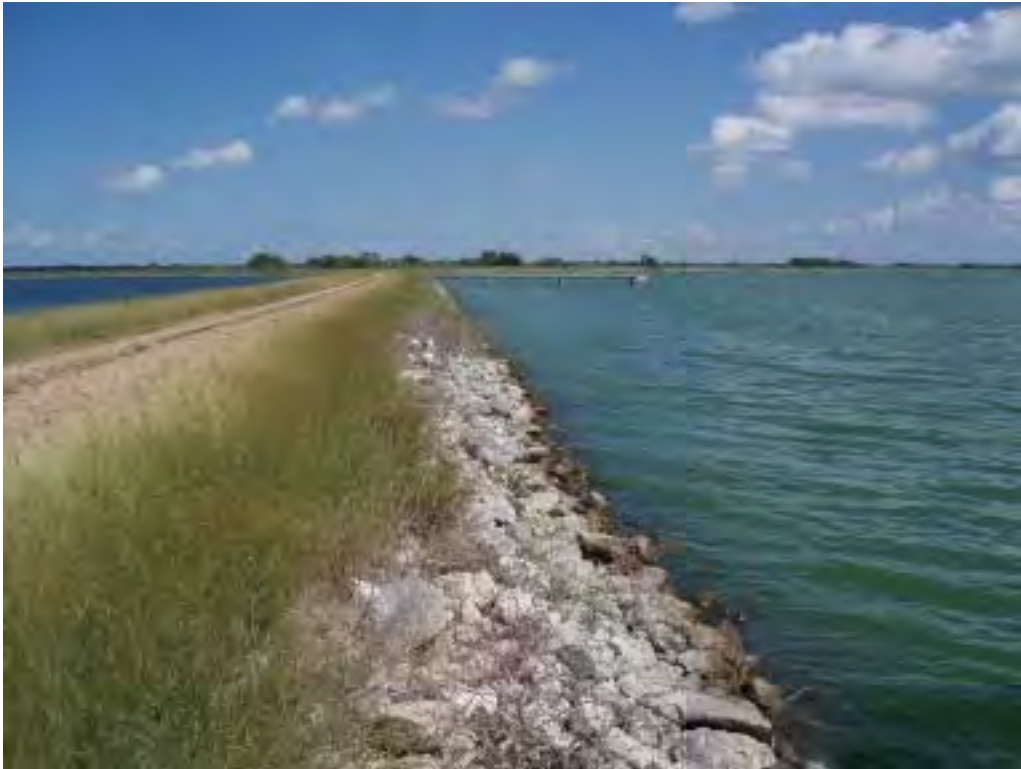
Photo No. 3: Primary Ash Pond - Southwest slope of divider embankment from northwest corner, looking southeast.

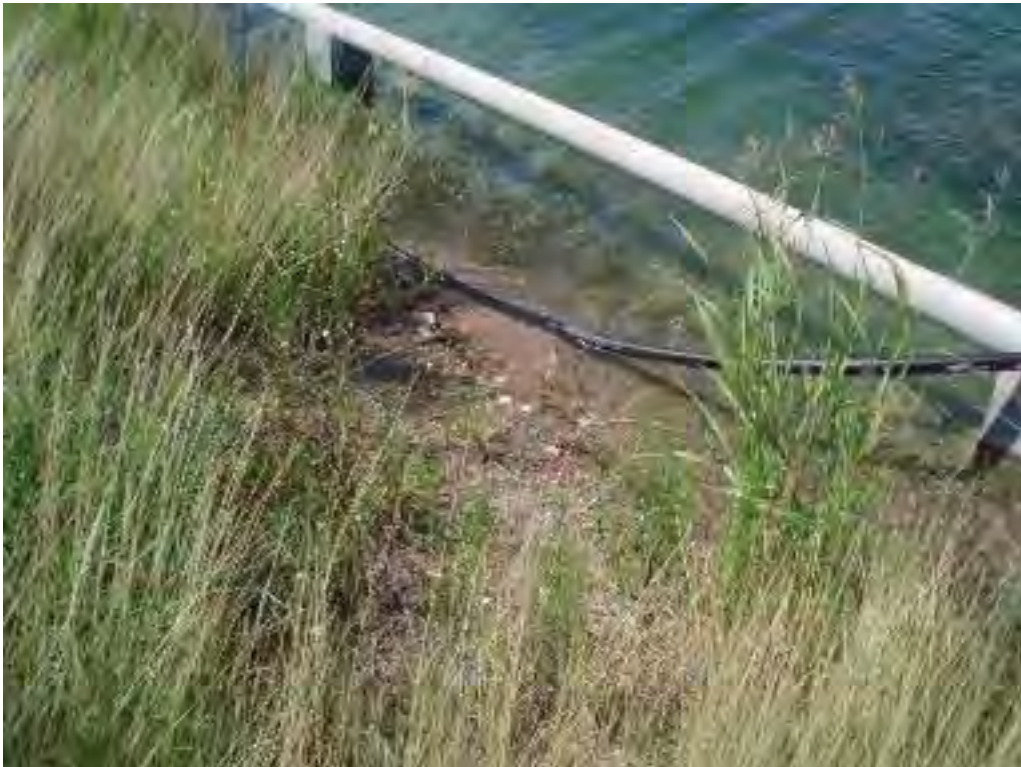
No riprap was observed on the interior slopes. Grass and brush approximately 24 to 36 inches tall was observed growing on the top 1 to 2 feet. Below, the soil was exposed and there was approximately 1 to 2 feet of erosion from wave action (Photos 4 and 43).

Photo No. 4: Secondary Ash Pond - Northeast slope of divider embankment, looking at typical erosion area from wave action. Erosion area shown approximately 6'Wx2'D.

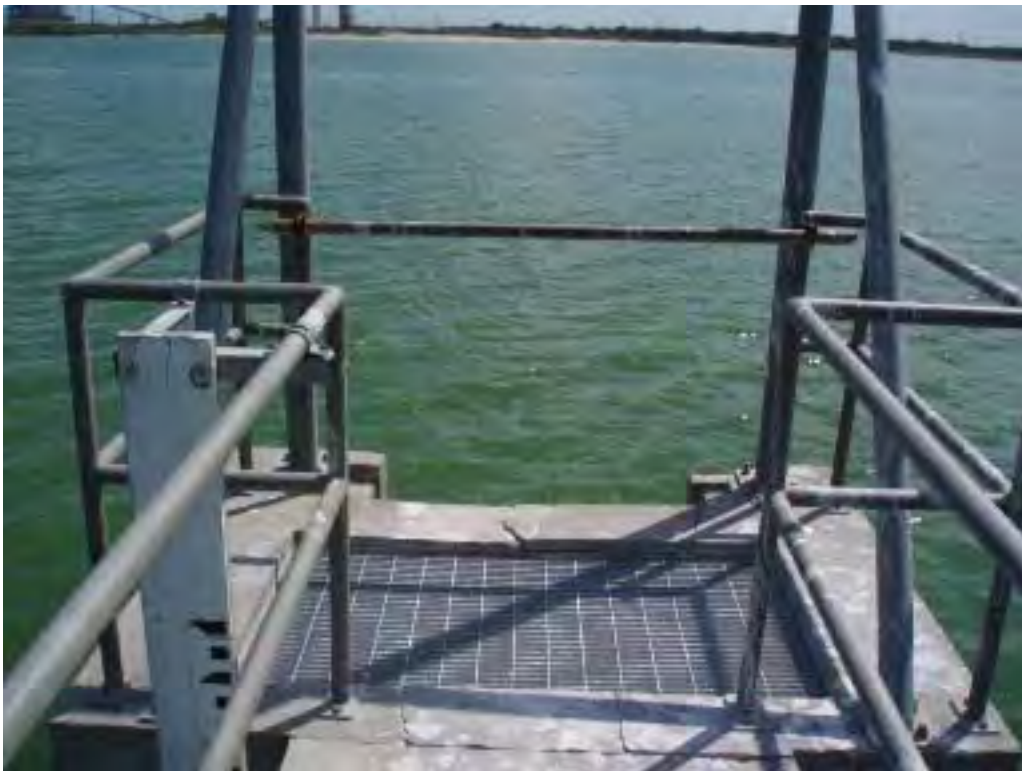
There is a staff gage on the inlet structure that is used to measure the impoundment water level elevation (Photos 6 and 8). Based on information provided by IPA personnel, the pond water levels are monitored daily. The pond water level during the site visit was at El. 136.8.

Photo No. 8: Close-up of inlet structure, looking southwest.

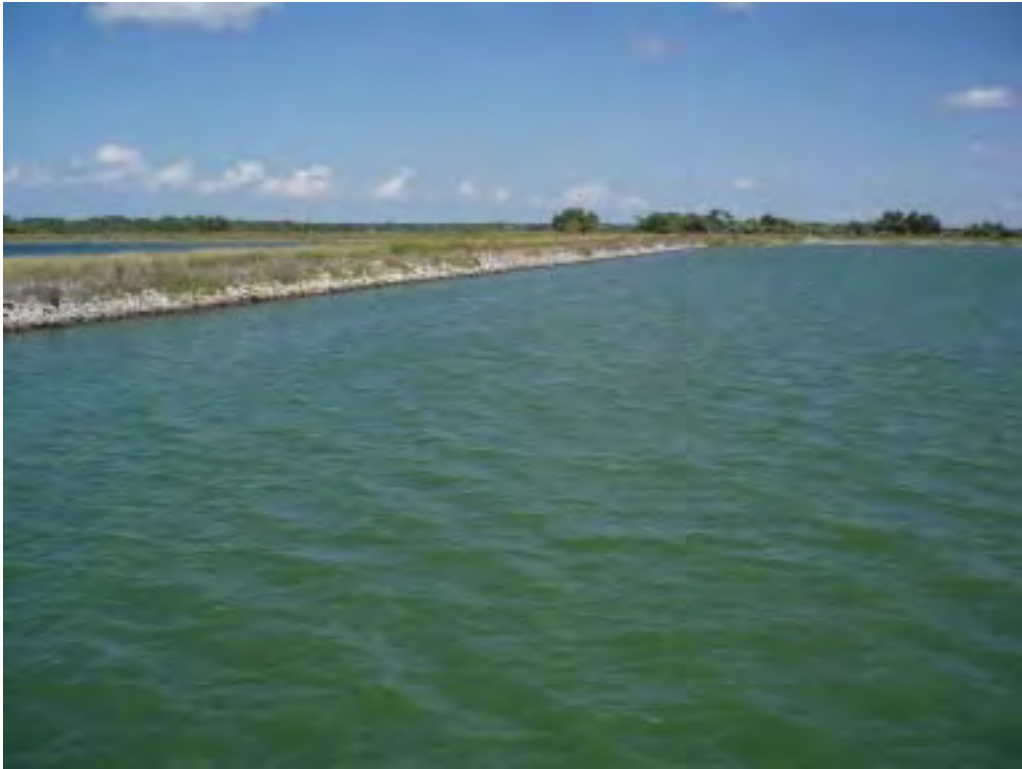
Photo No. 9: Primary Ash Pond - Southwest slope of divider embankment, looking southeast.

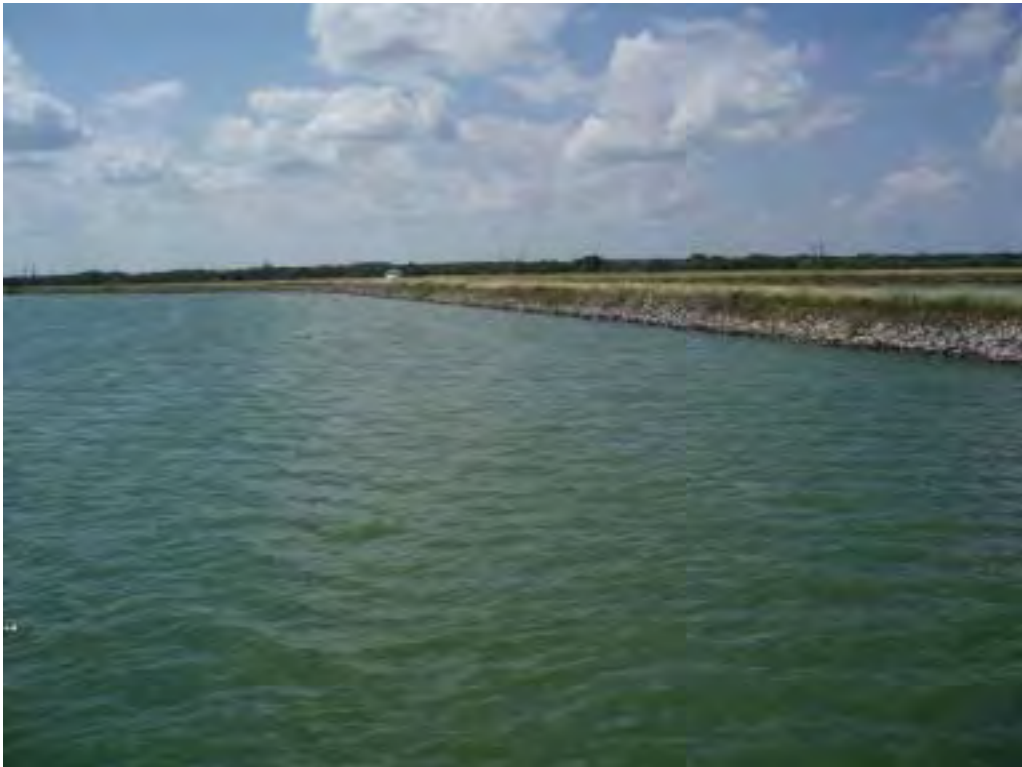
Photo No. 10: Primary Ash Pond - Southwest slope of divider embankment, looking northwest.

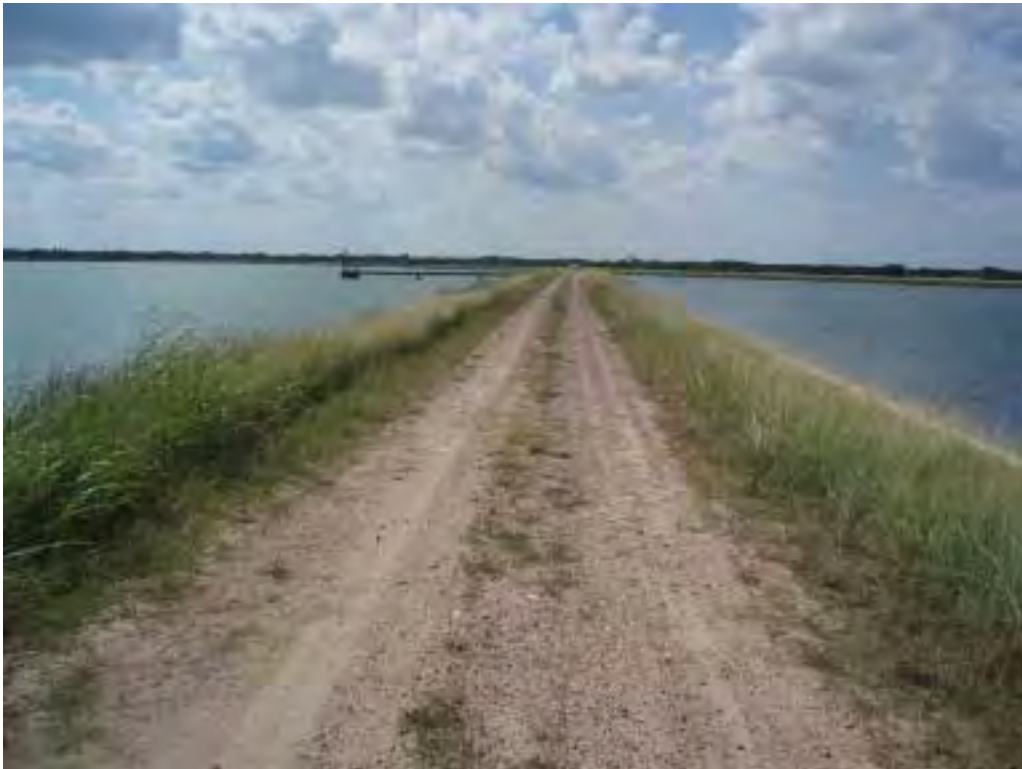
Photo No. 14: Crest of divider embankment, looking northwest.

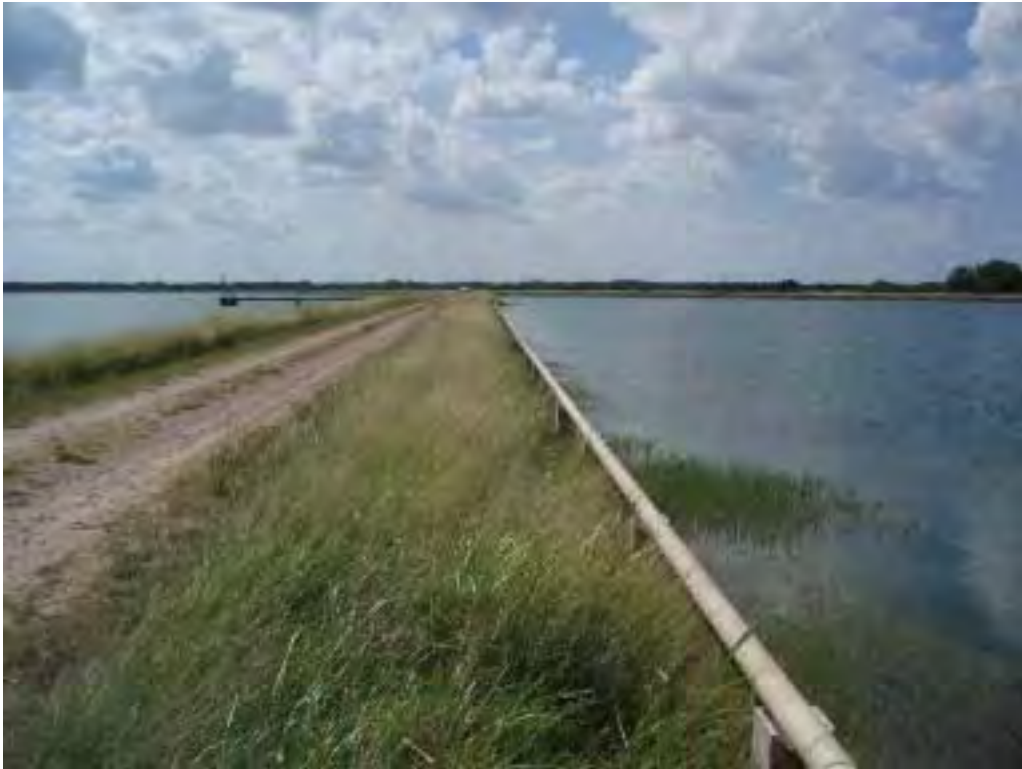
Photo No. 15: Secondary Pond - Northeast slope of divider embankment, looking northwest.

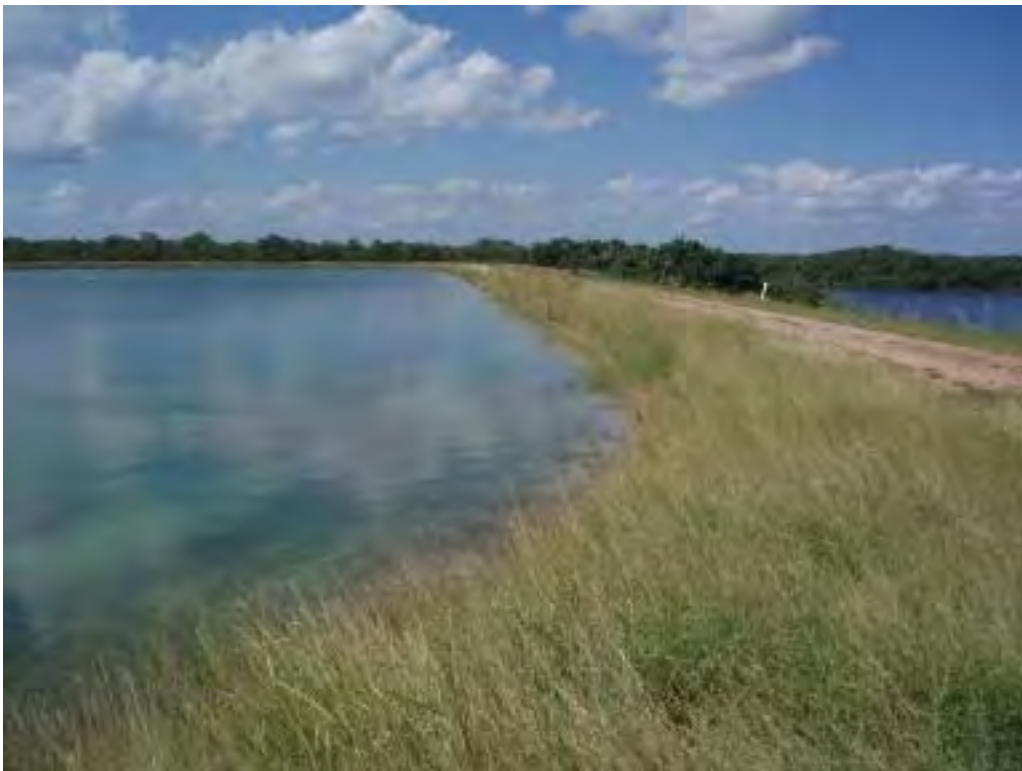
Photo No. 16: Secondary Pond - East embankment interior slope , looking north.

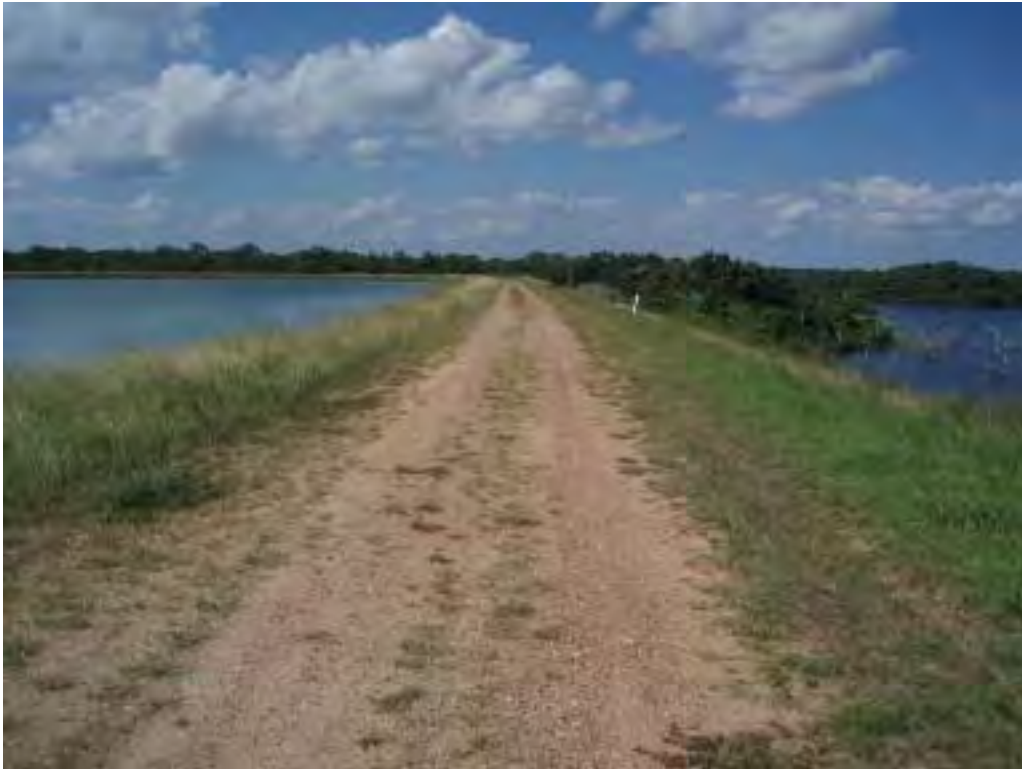
Photo No. 17: Secondary Pond – East embankment crest, looking northeast.

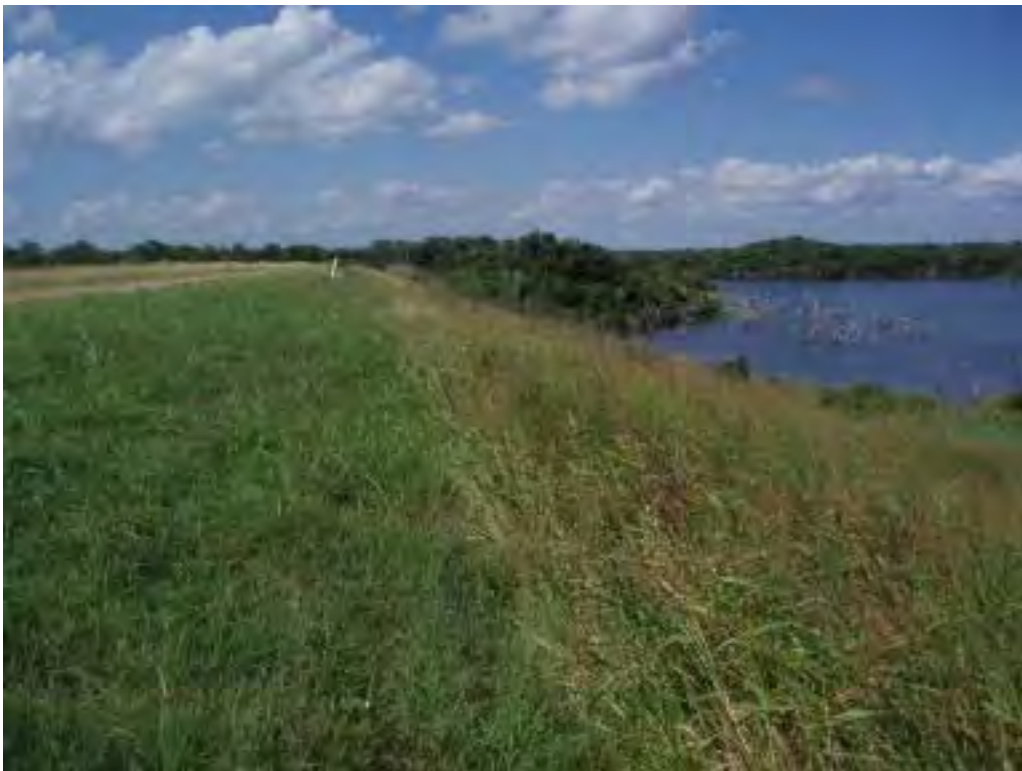
Photo No. 18: Secondary Pond – East embankment exterior slope, looking northeast.

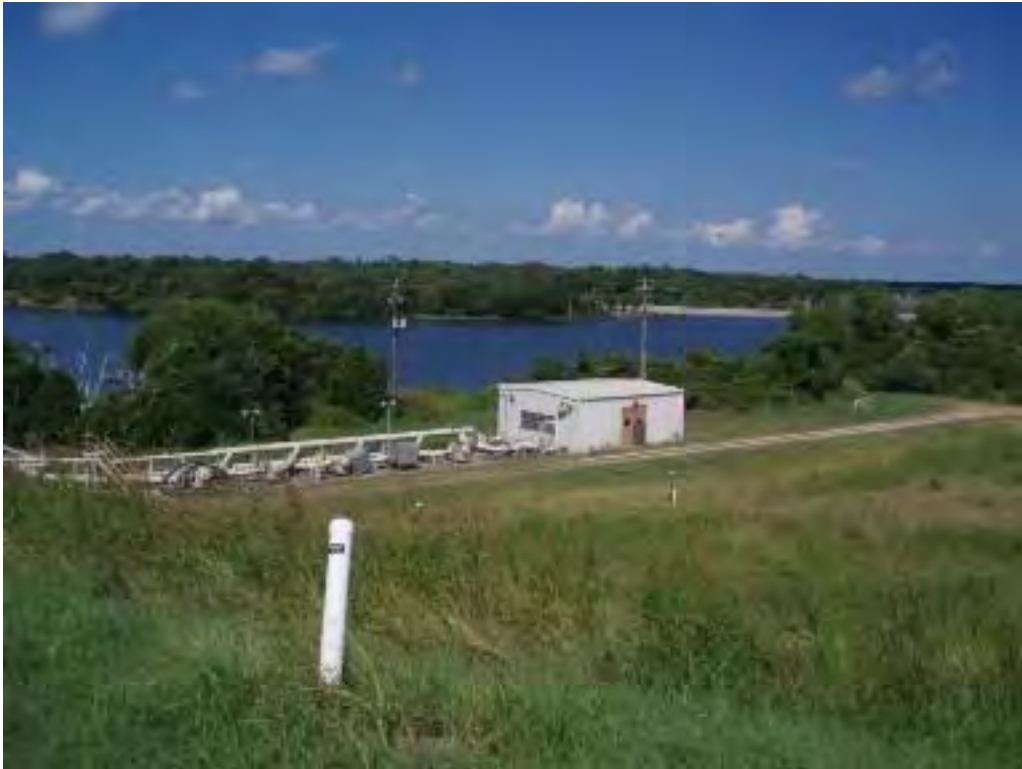
The outlet pipes and recirculating pump station appeared to be in fair condition (Photos 19, 20, 21, and 24). The outfall in the discharge canal appeared to be in poor condition (Photo 22). The discharge channel has deteriorated. The concrete is overgrown with vegetation, cracked and spalled, and sections of the channel are missing exposing the underlying soil.

Photo No. 19: Secondary Pond – East embankment downstream area, looking southeast at the recirculating pump station and Coletto Creek Reservoir.

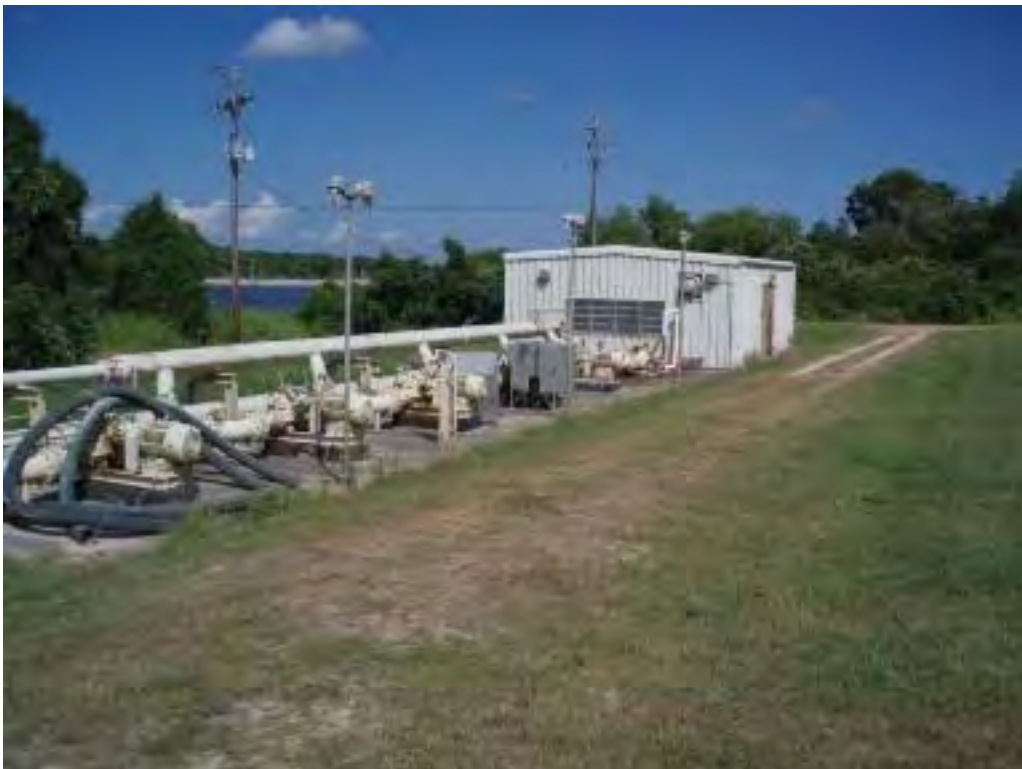
Photo No. 20: Overview of recirculating pump station, looking southeast.

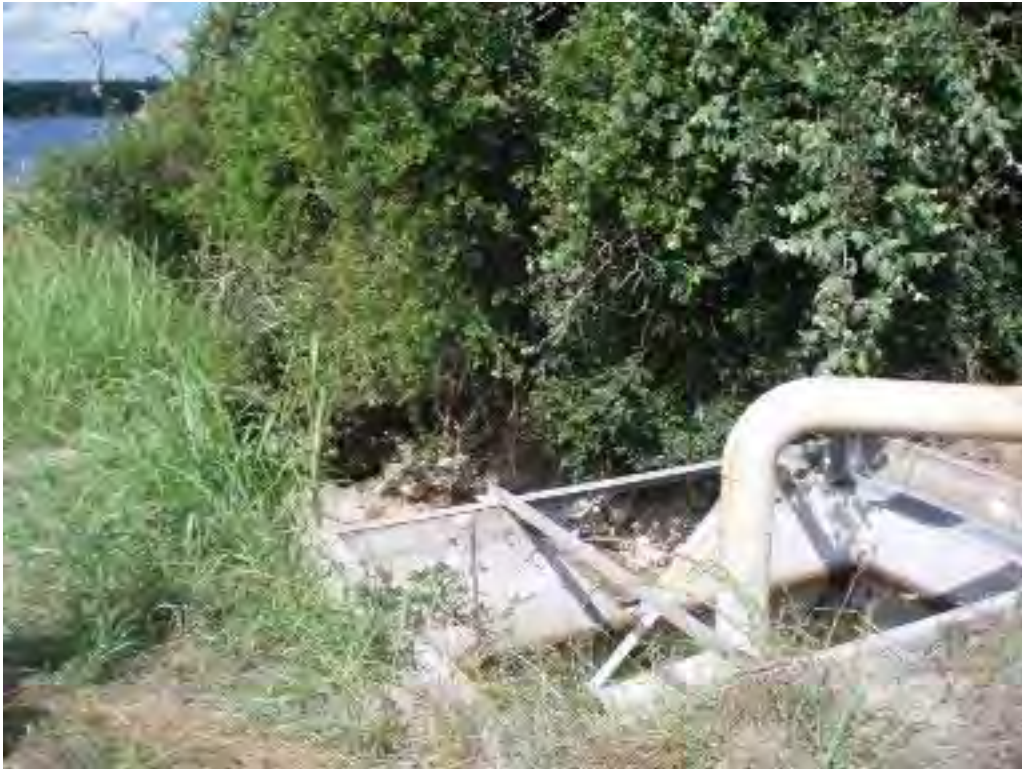
Photo No. 21: Overview of secondary pond 8-inch-diameter Outfall 003 with weir box.

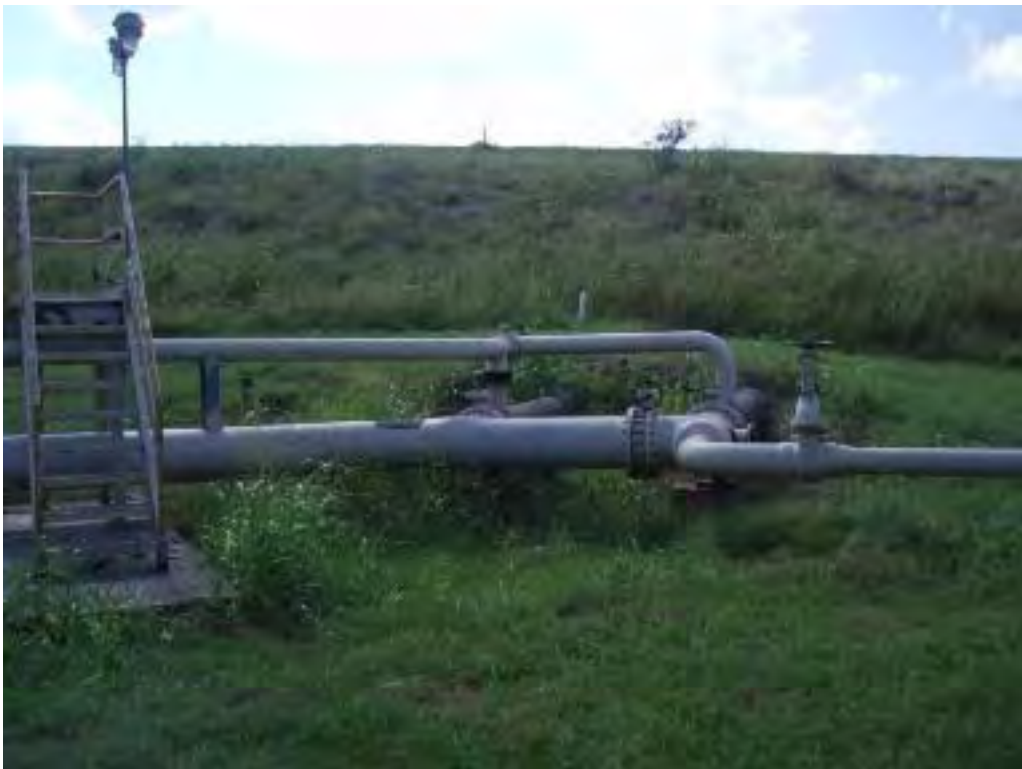
Photo No. 24: Secondary Pond - outlet pipes connected to outfall and recirculating pump station.

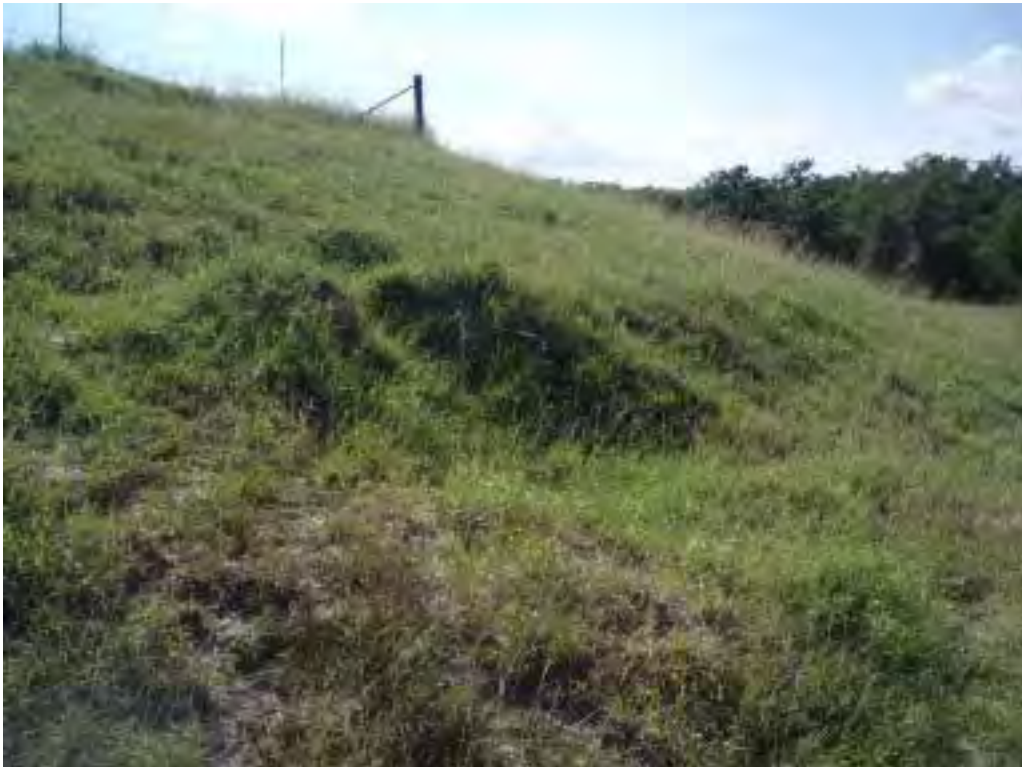
Photo No. 32: Secondary Pond – North embankment exterior slope, looking at 8'Lx8'Wx3'D depression.

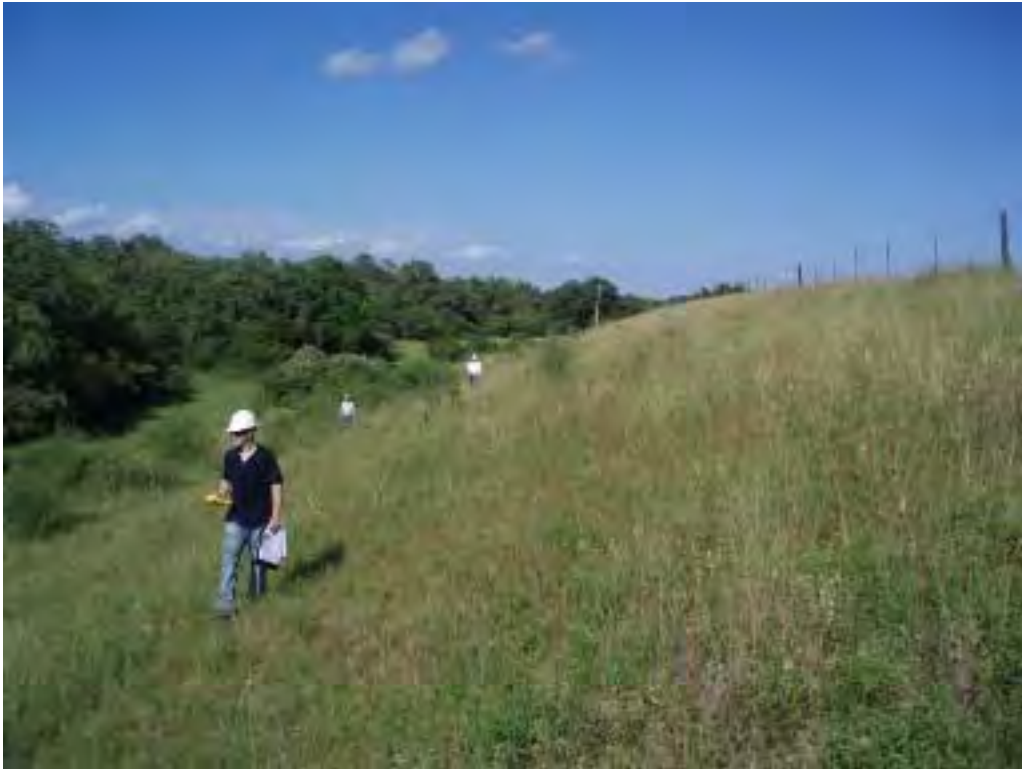
Photo No. 37: Secondary Pond – North embankment exterior slope, looking east.

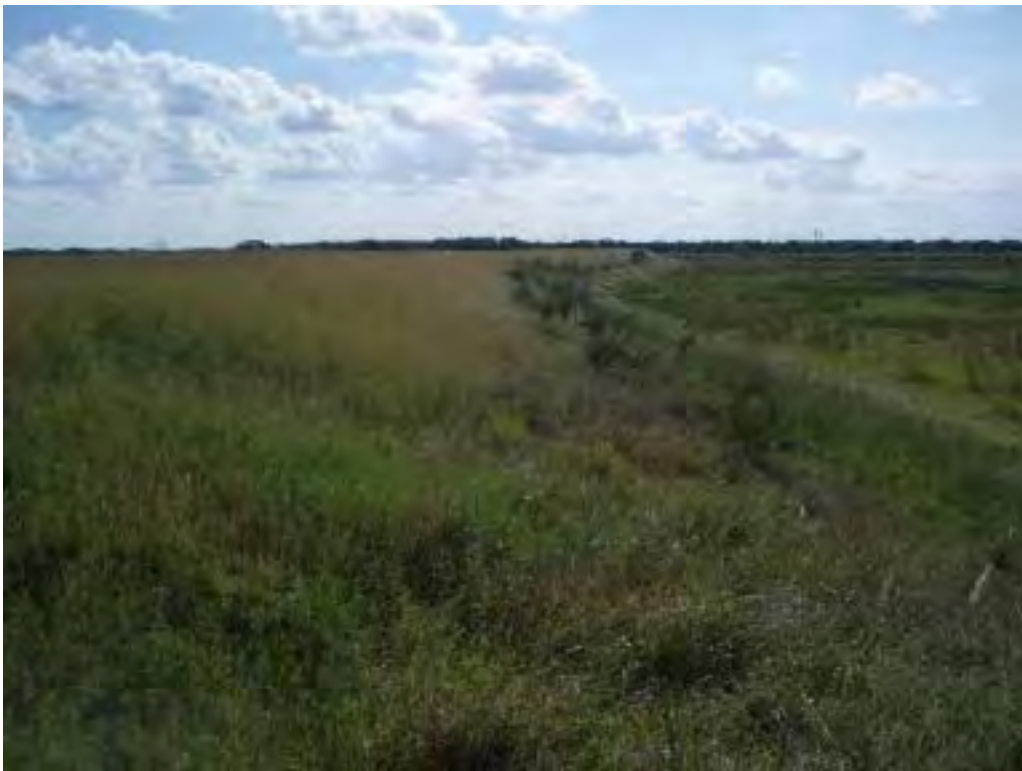
Photo No. 38: Secondary Pond – North embankment exterior slope, looking west.

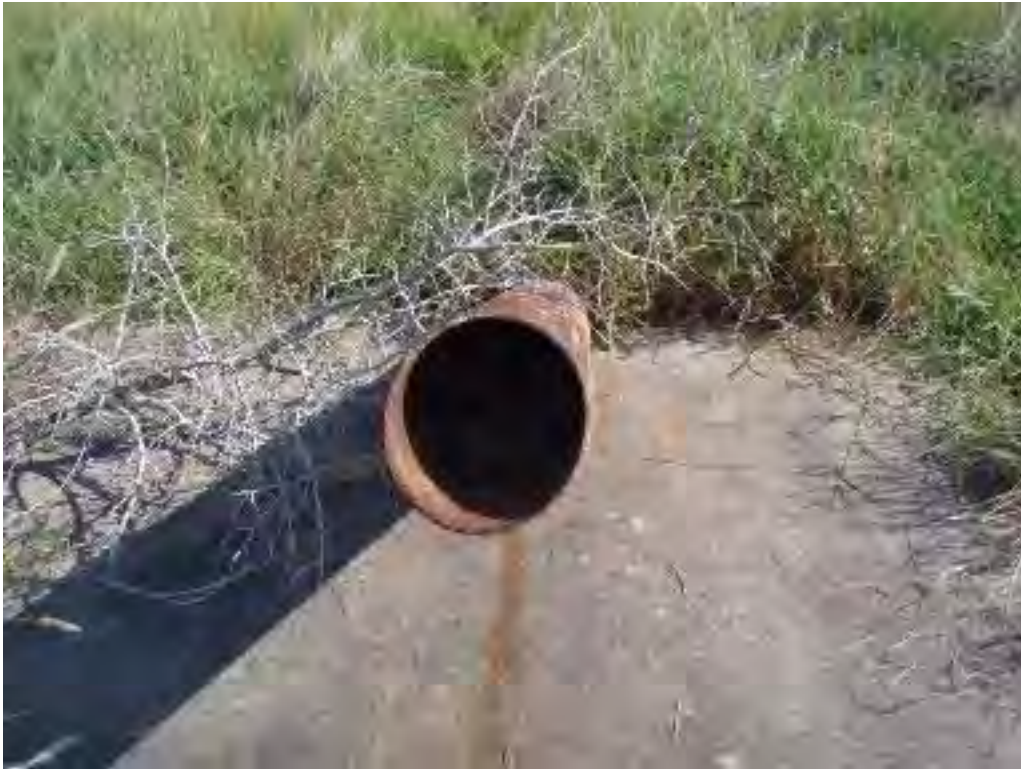
On the north embankment a 12-inch-diameter DI pipe was observed. Based on information from IPA personnel, an 8-inch-diameter pipe (Photos 1, 4, and 15) from the recirculating pump station conveys water back to the Secondary Pond or the outlet pipe located in the evaporation pond (Photo 39).

Photo No. 39: Secondary Pond, north embankment exterior slope, looking at 12-inch-diameter DI recirculating pipeline. Pipeline discharges from recirculating pump station into Evaporation Pond.

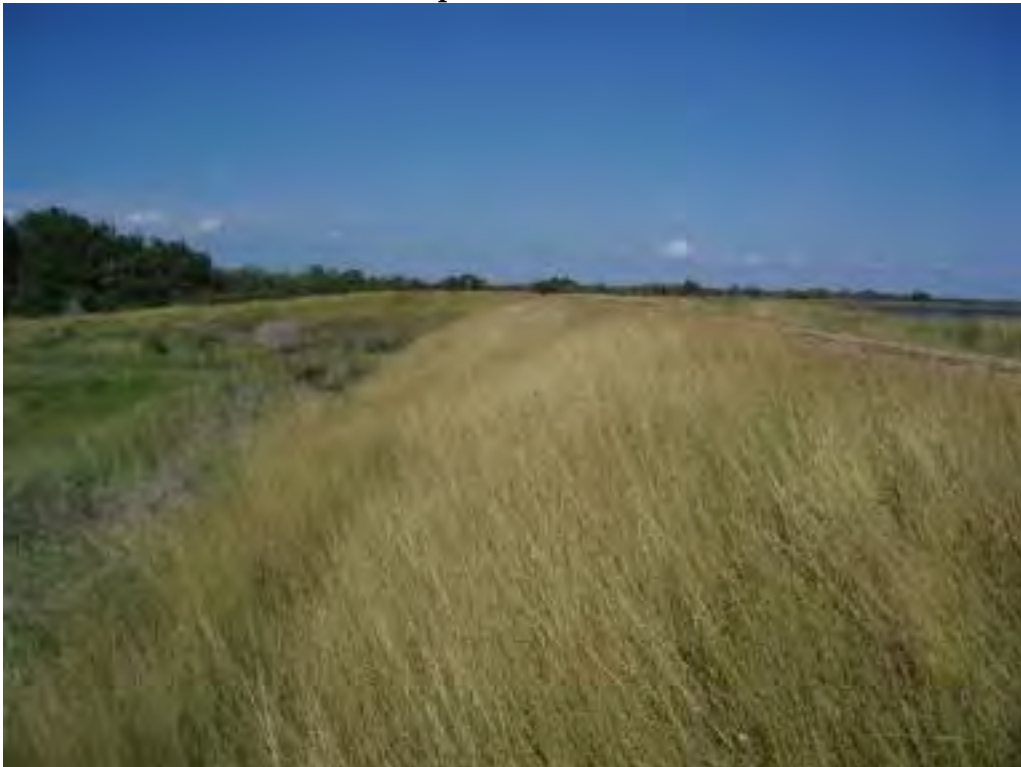
Photo No. 40: Secondary Pond – North embankment exterior slope, looking east.

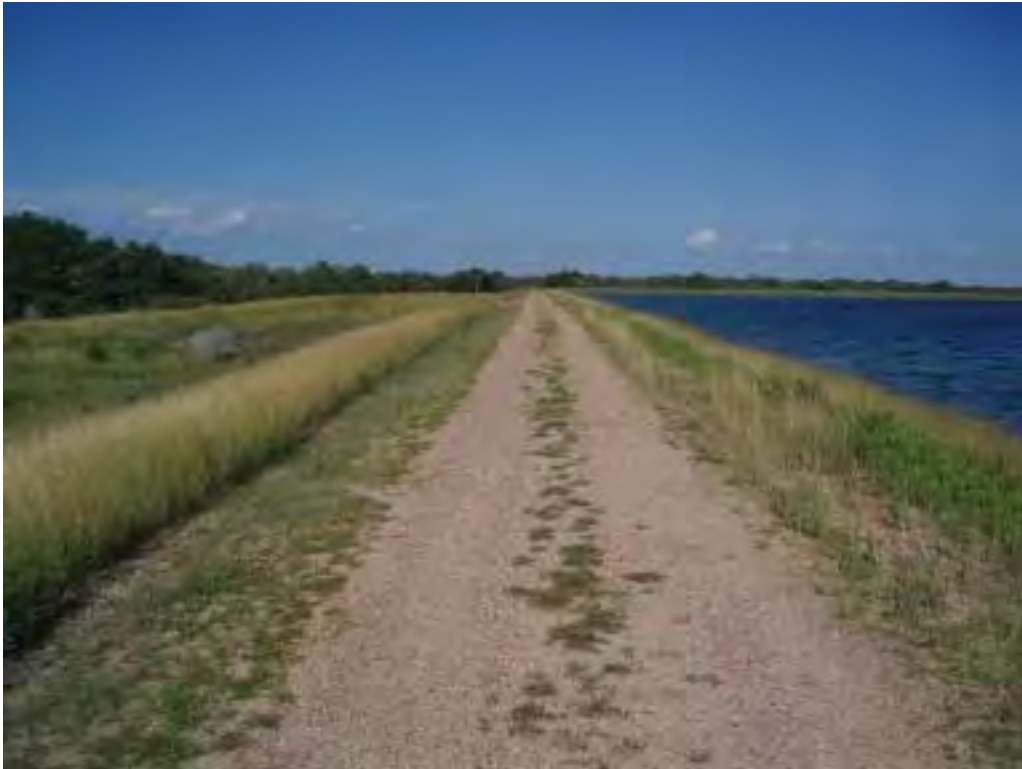
Photo No. 41: Secondary Pond – North embankment crest, looking east.

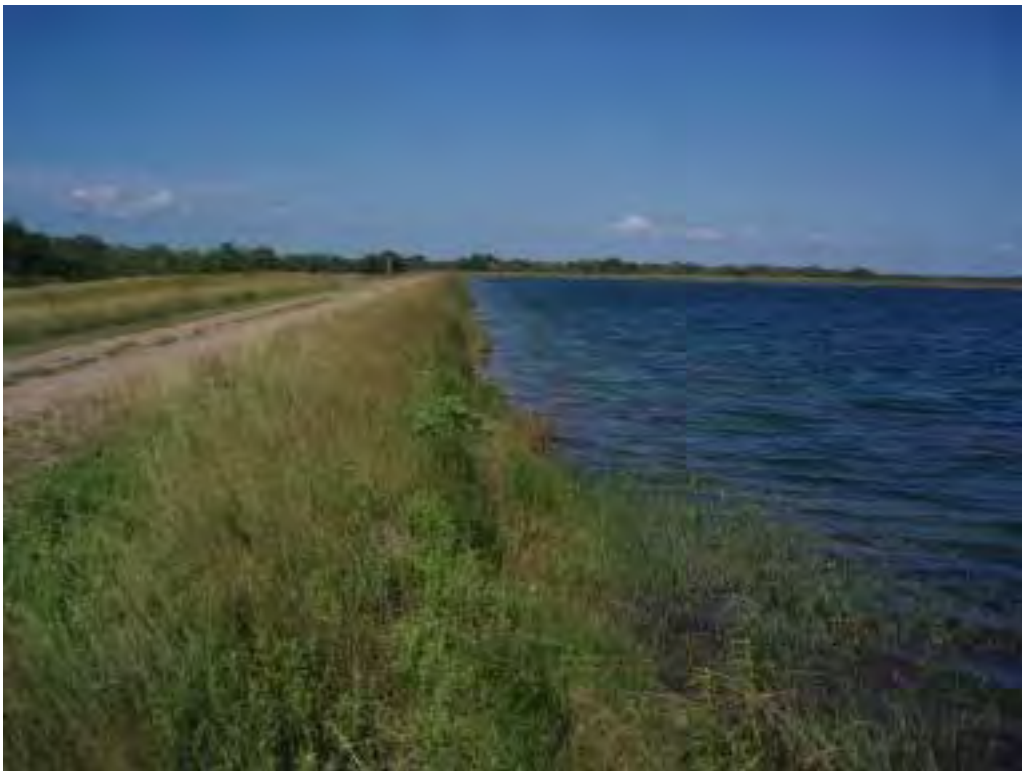
Photo No. 42: Secondary Pond – North embankment interior slope, looking east.

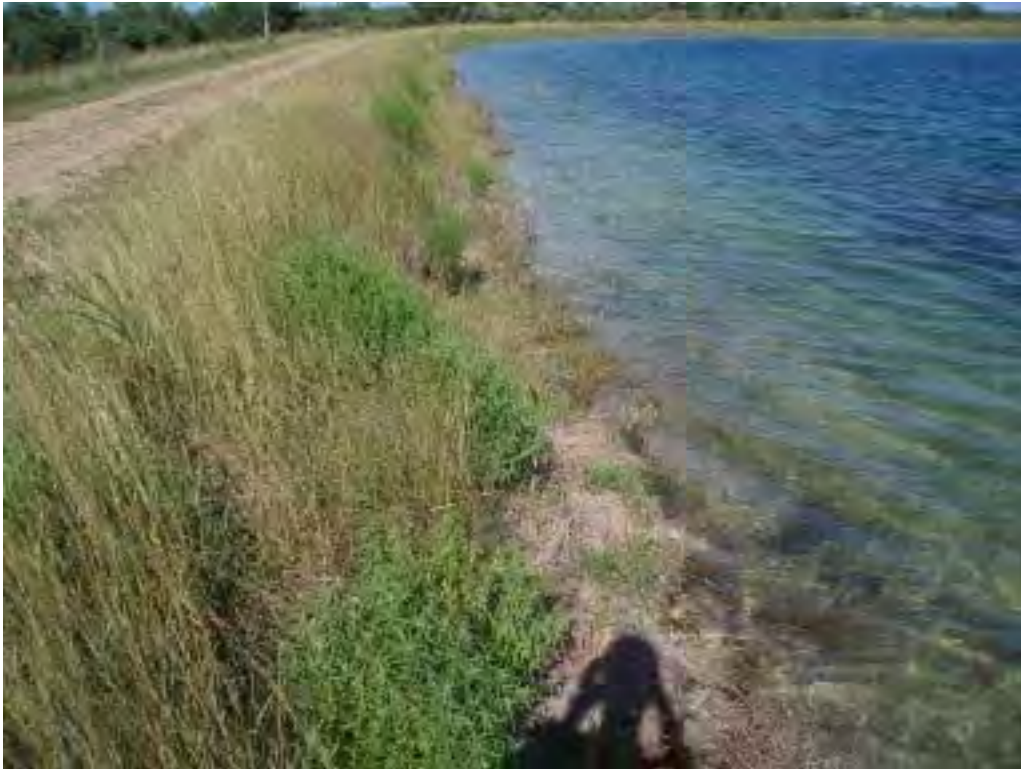
Photo No. 43: Secondary Pond – North embankment interior slope, looking east at typical 1 to 2 feet of erosion from wave action.

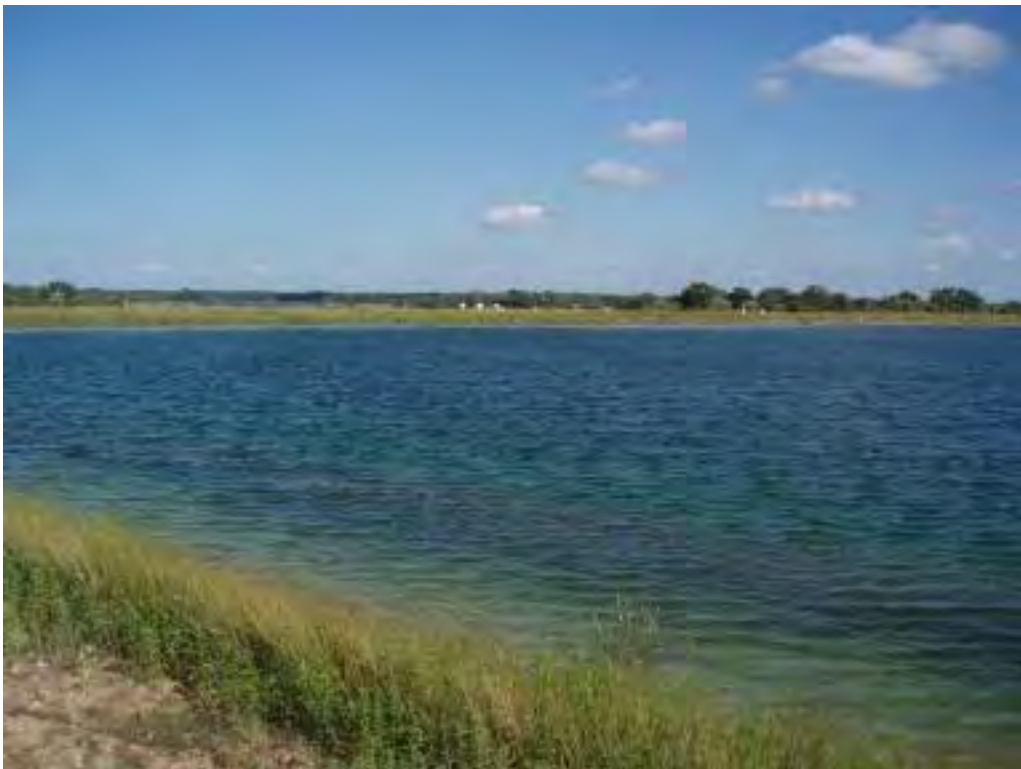
Photo No. 44: Secondary Pond – Looking southeast at east embankment interior slope from north embankment.

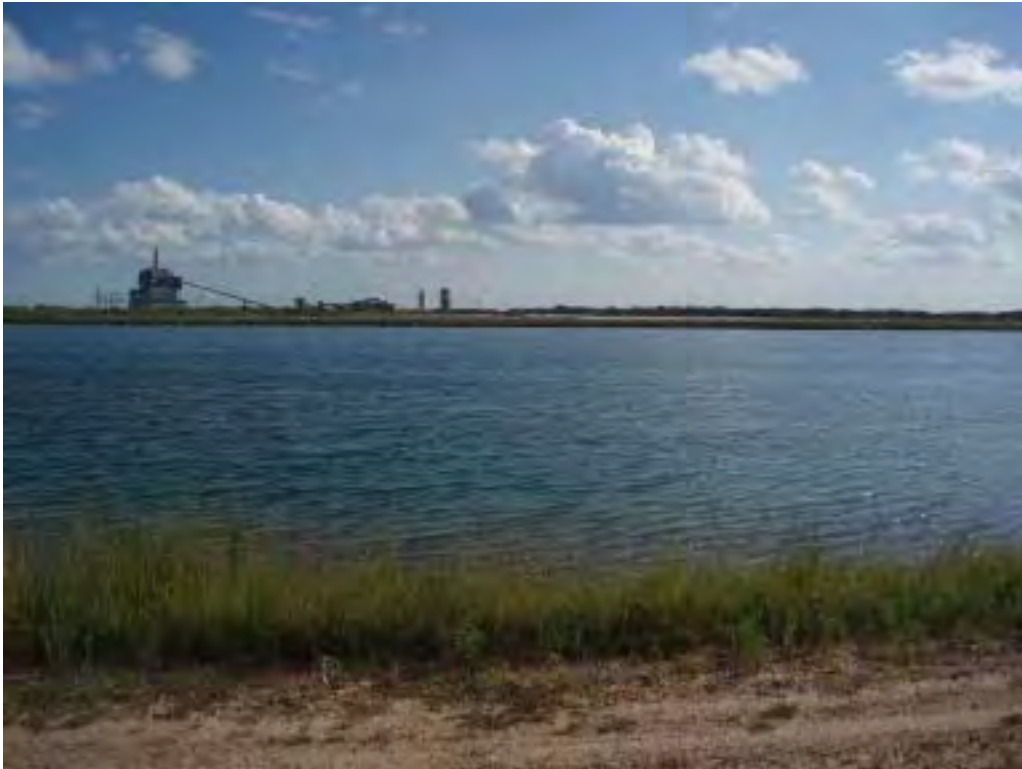
Photo No. 45: Secondary Pond - Looking southwest from north embankment at interior slope of divider embankment.

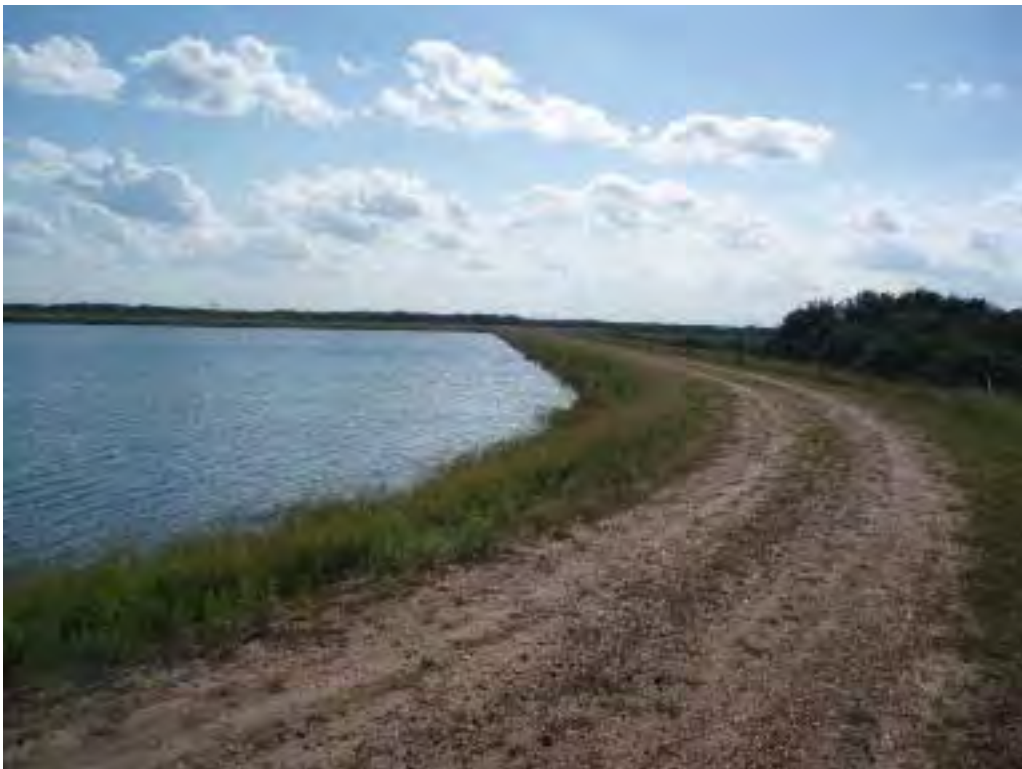
Photo No. 46: Secondary Pond – North embankment interior slope and crest, looking west.
